# **Pentium® II Processor Specification Update**

Release Date: October 1997

Order Number: 243337-006

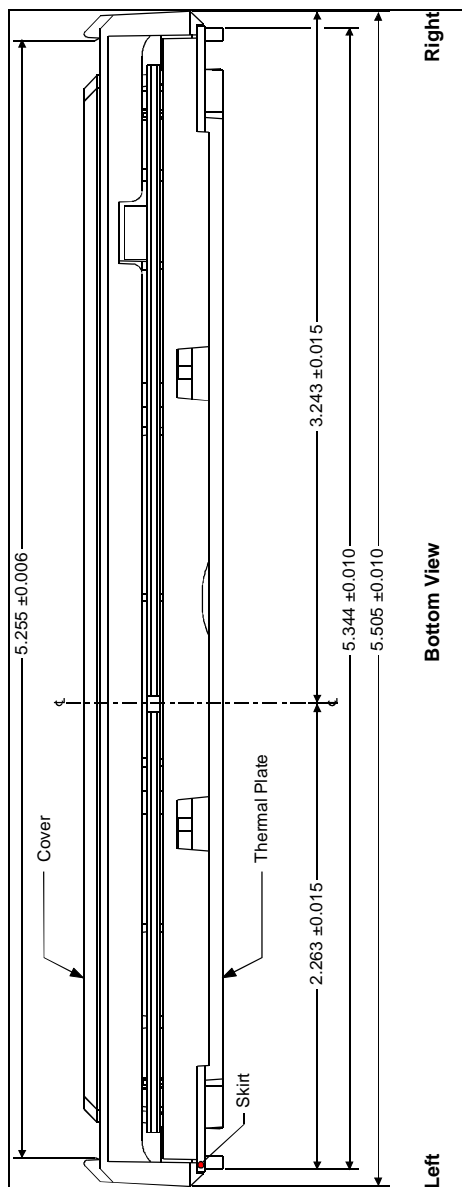
Figure 7. S.E.C. Cartridge Bottom Side View

**\*\* Added Figure 9, Figure 7 corrected a dimension, Figure 8 clarified dimensions, Figure 10 corrected dimensions**

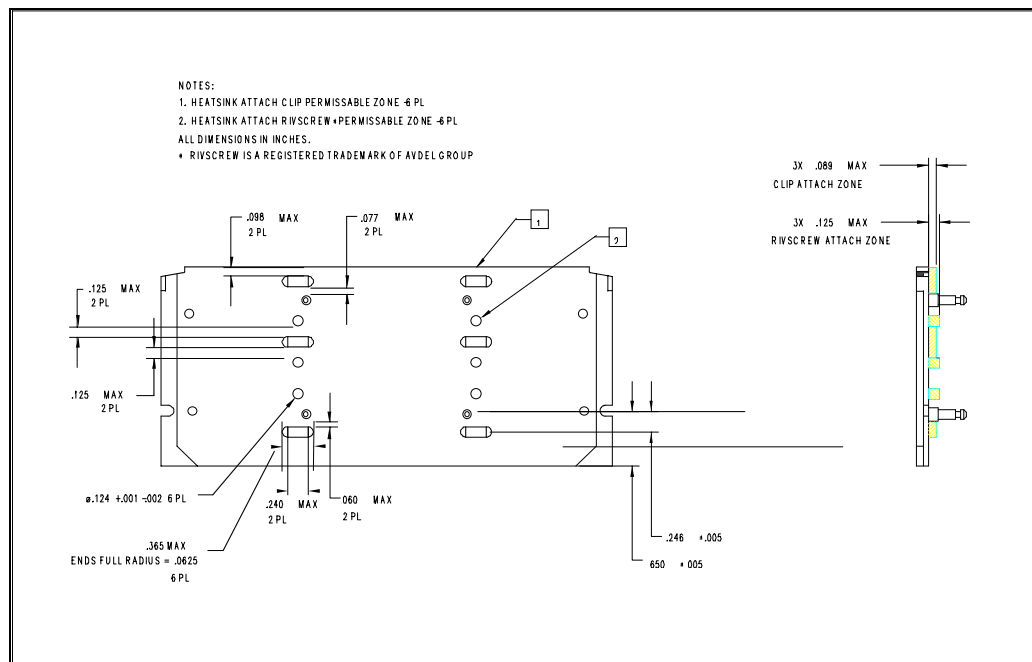
**Figure 12. Heatsink Attachment Mechanism Design Space**

A change to the attach mechanism specification is provided below. The original specification for clearance of heatsink attach solutions is provided in Section 4.3 (and Figure 23 and Figure 24) in the *Pentium® II Processor at 233 MHz, 266 MHz and 300 MHz* datasheet. Figure 11 shows the revised maximum specifications for heatsink clip and RivscREW® attach mechanism designs. All heatsink clip and RivscREW attachment solutions must remain within the respective maximum “permissible” zone as detailed in Figure 11.

The thermal plate shown in Figure 11 is used to portray the heatsink attach mechanism design space for the future Slot 1 processors. However, the maximum “permissible” design space is also valid for both the current Pentium II and future Slot 1 processors.

Please review the proposed specifications to guarantee compatibility with existing Pentium II and future Slot 1 processor heatsink attachment solutions. Note that the required heatsink attachment solution space should not exceed the maximum proposed design space while installed or during the installation and removal procedure.
